Central Valley Groundwater Monitoring Collaborative Five-Year Assessment Report

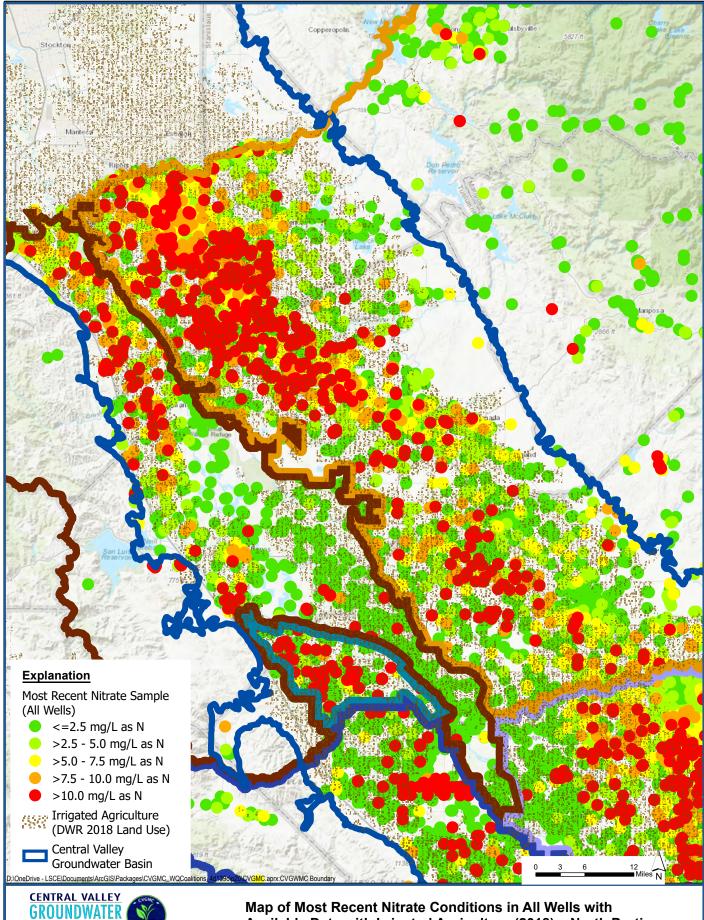
Available Data with Irrigated Agriculture (2018) – North Figure 5-3d

Map of Most Recent Nitrate Conditions in All Wells with

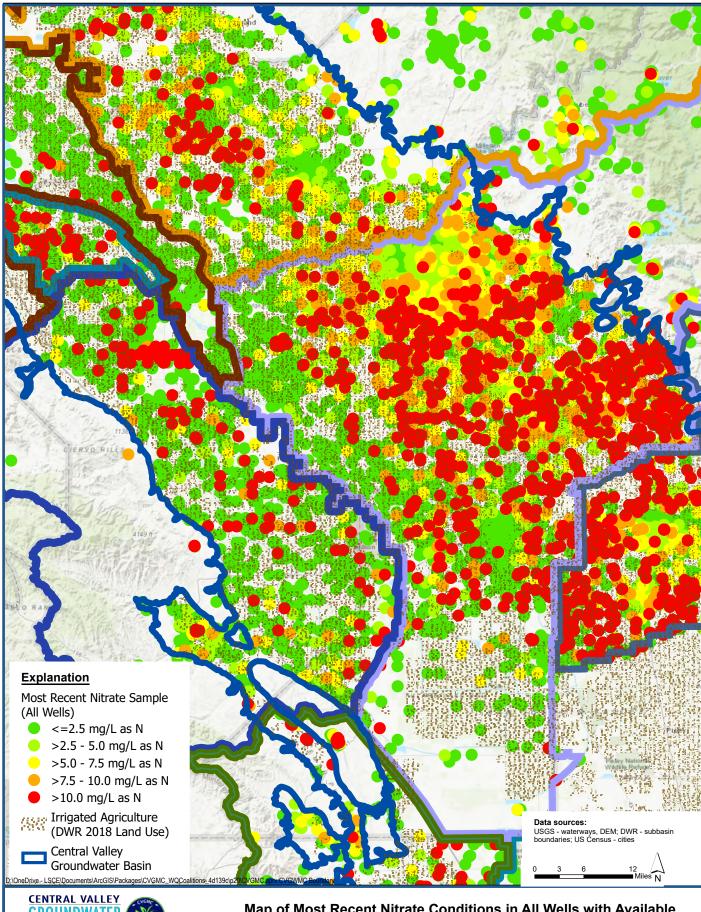
Figure 5-3e

Map of Most Recent Nitrate Conditions in All Wells with Available

Data with Irrigated Agriculture (2018) – Central Portion

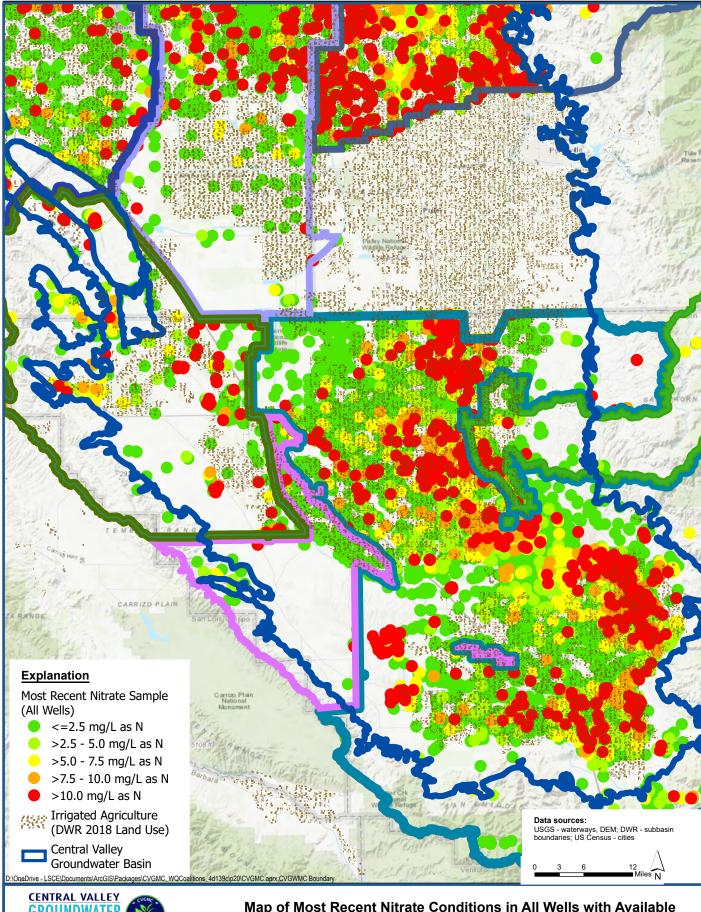
Figure 5-3f

Map of Most Recent Nitrate Conditions in All Wells with Available

Data with Irrigated Agriculture (2018) – South Portion

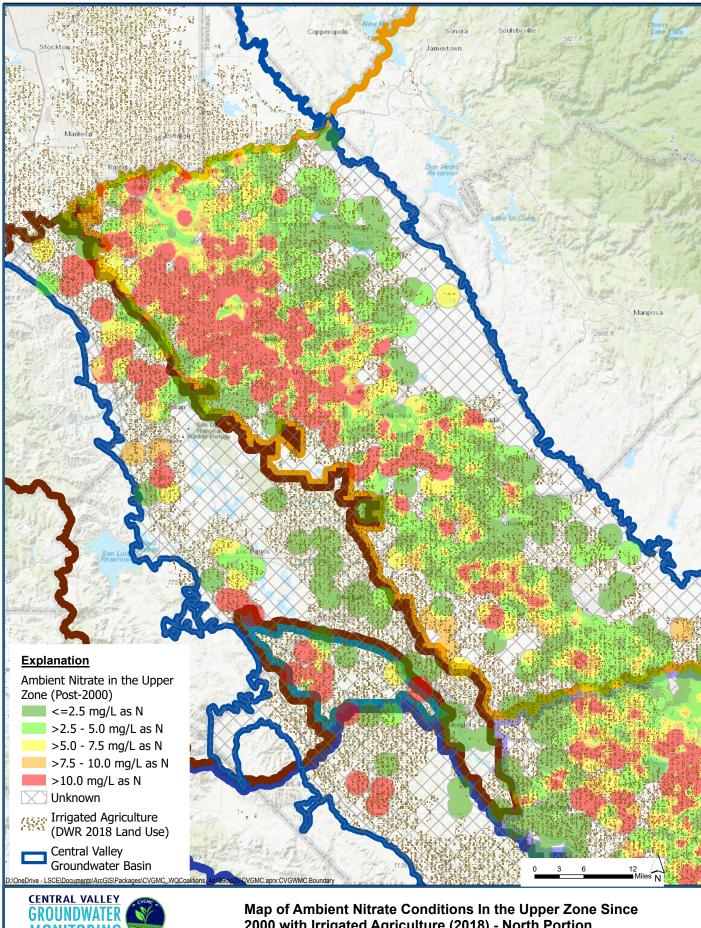
Map of Ambient Nitrate Conditions In the Upper Zone Since 2000 with Irrigated Agriculture (2018) - North Portion Figure 5-4a-4

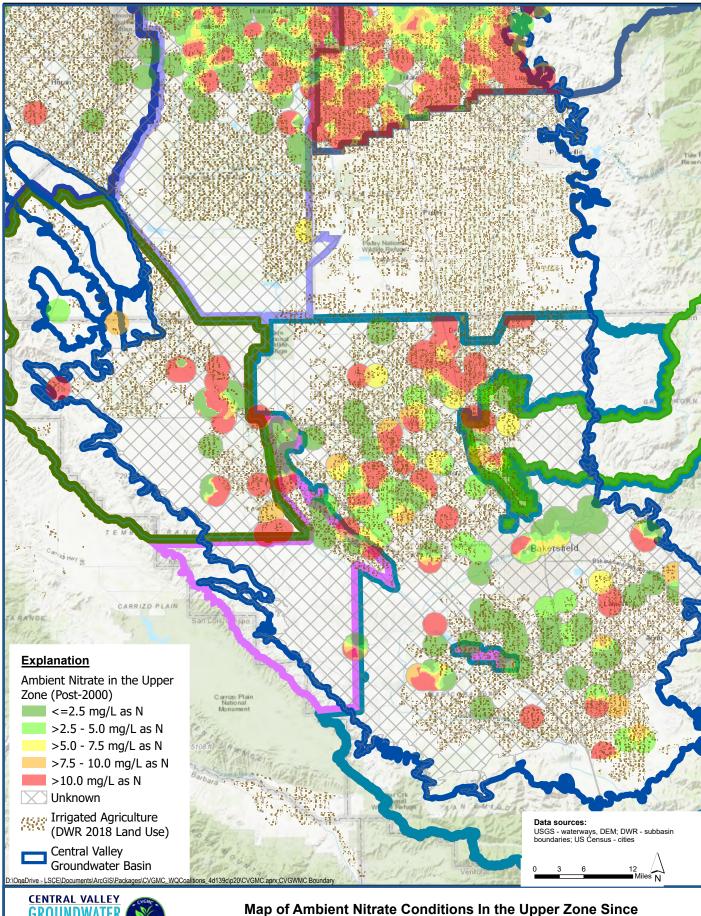
Map of Ambient Nitrate Conditions In the Upper Zone Since
2000 with Irrigated Agriculture (2018) - South Portion
Figure 5-4a-6

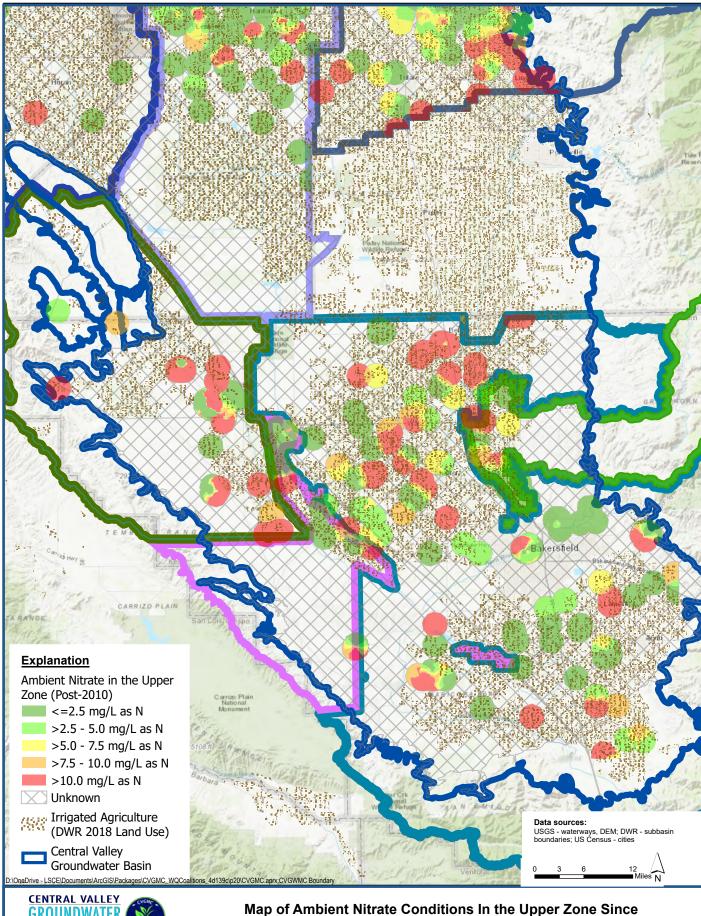
Figure 5-4b-6

Map of Ambient Nitrate Conditions In the Upper Zone Since 2010 with Irrigated Agriculture (2018) - South Portion

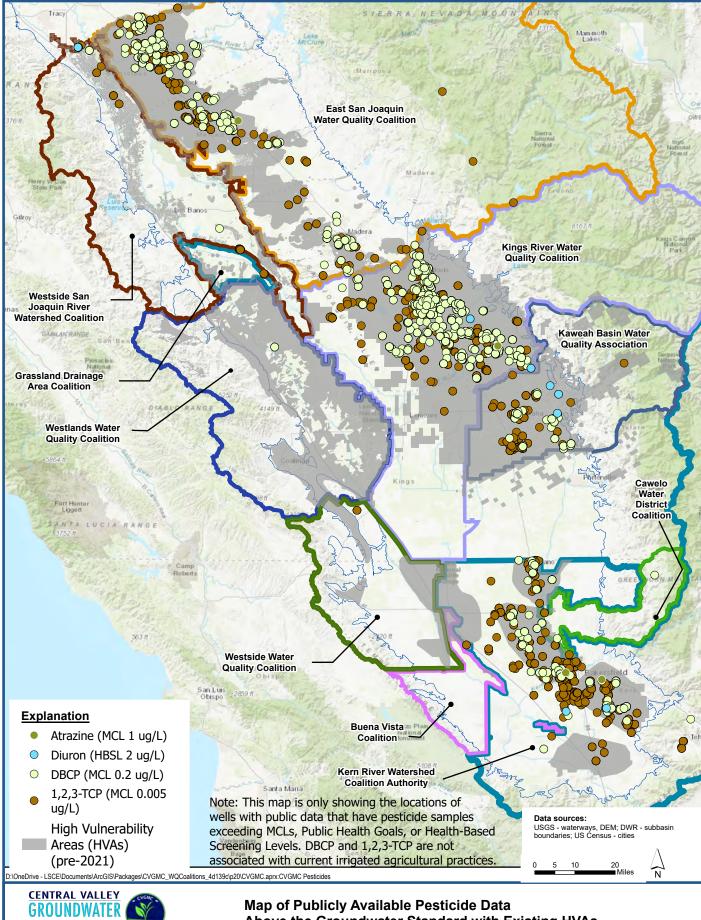
Figure 5-19b

Above the Groundwater Standard with Existing HVAs
